## Caracterización de árboles de riesgo en el Parque Nacional Viveros de Coyoacán, Ciudad de México

### Risk trees in *Viveros de Coyoacán* National Park, Mexico City

Liliana Muñoz Gutiérrez<sup>1\*</sup>, Ramiro Pérez Miranda<sup>1</sup>, José Francisco Reséndiz Martínez<sup>1</sup>, Rodolfo Reyes Robles<sup>2</sup>

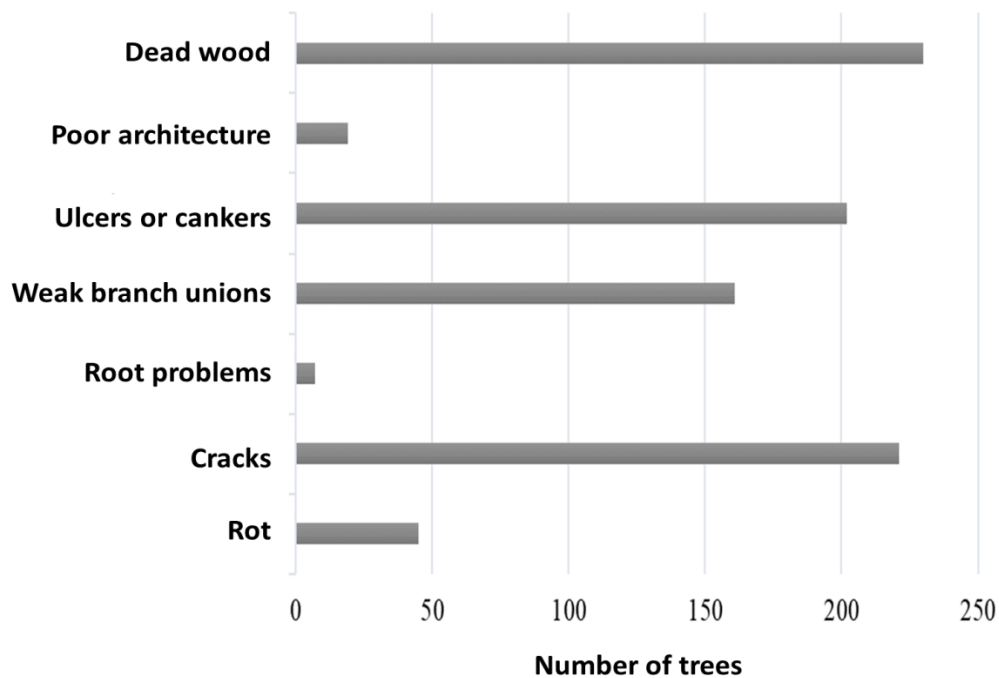
The characteristics that can be defined as defects associated with the trees (Figure 2) showed that just over 70 % of the trunks of the sampled population have cracks and dead wood caused by cankers, weak unions of branches, injuries due to mechanical damage or by vandalism. These factors caused the formation of cavities, which in most of them were the entrance point for pathogenic agents that caused

the deterioration or reduction of the stability and the physical-mechanical properties of the standing tree, since the phytopathogens were present in branches, trunks and roots. In half of the trees, weak unions were recorded in the branches, which include the branches produced by epicormic shoots in response to injuries or environmental stress, and 60 % developed ulcers or cankers in the branches. Fractures or cracks often originated in these areas, with a high risk of causing the specimen to fall.

**Figure 2.** Defects presented by risk trees in the *Viveros de Coyoacán* Park, Mexico City.

Regarding the degree of risk, it was determined that 131 trees of the total represent extreme risk (32 %) and high risk (12 %) (Table 2, Figure 2). Related defects are rot, cracks, weak branch joints, cankers and dead wood. Pokorny and Albers (2003)

Based upon the results, the management actions are basic to improve the conditions of the Park and provide security to the users; formation and sanitation pruning, surgeries in the hollows and cavities of the trees are recommended, in addition, carry out work to loosen the soil inside the planters. On the other hand, in future programs of planting or replacement of specimens, it is suggested to diversify the species; therefore, it is important to undertake a training program for the operating personnel, with the advice of engineers or technicians who participate in the work of the Park, with proper work and safety equipment.

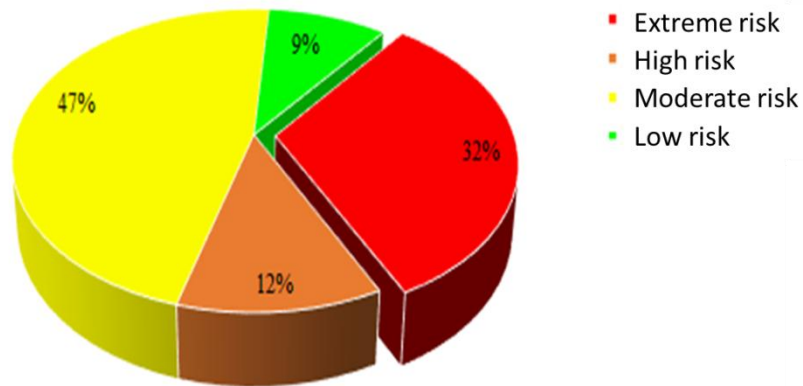
In the present work, the highest proportion of the inventoried individuals were classified with a yellow code (47 %), that is, moderate risk (Figure 3). Finally, only 9 % corresponded to the category without any risk, and the species that made up this group were *Phoenix canariensis* Chabaud and *Yucca elephantipes* Baker.

**Figure 3.** Percentage of trees at risk in the *Viveros de Coyoacán* Park, Mexico City.
