Daño a la infraestructura (pavimento) causado por el arbolado urbano en Puerto Vallarta, Jalisco

Damage to infrastructure (pavement) caused by urban trees in Puerto Vallarta, Jalisco

Tahamara Esquivel¹, Sandra Quijas^{1*}

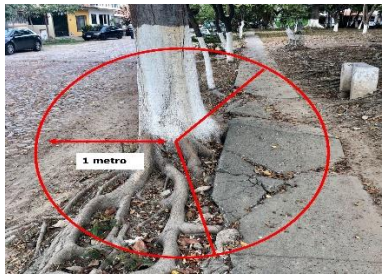
Table 2. Infrastructure damage percentage categories and scores.

Illustrative image of the visual assessment	Damage percentage category	Score

No damage	0
	1-20	1
	21-40	2
	41-60	3
	61-80	4
	81-100	5

The percentage of damage to the infrastructure was evaluated on the basis of the visible damage around the tree or palm. For the aims of this work, damage to foundations, drains, fences or any other type of construction was not considered because these were absent from the green areas. Having drawn an imaginary circle around the individual tree, with a radius of approximately one meter, the percentage of damage within the circle was determined, corresponding to one of the five categories already established and having an assigned score value (Table 2).

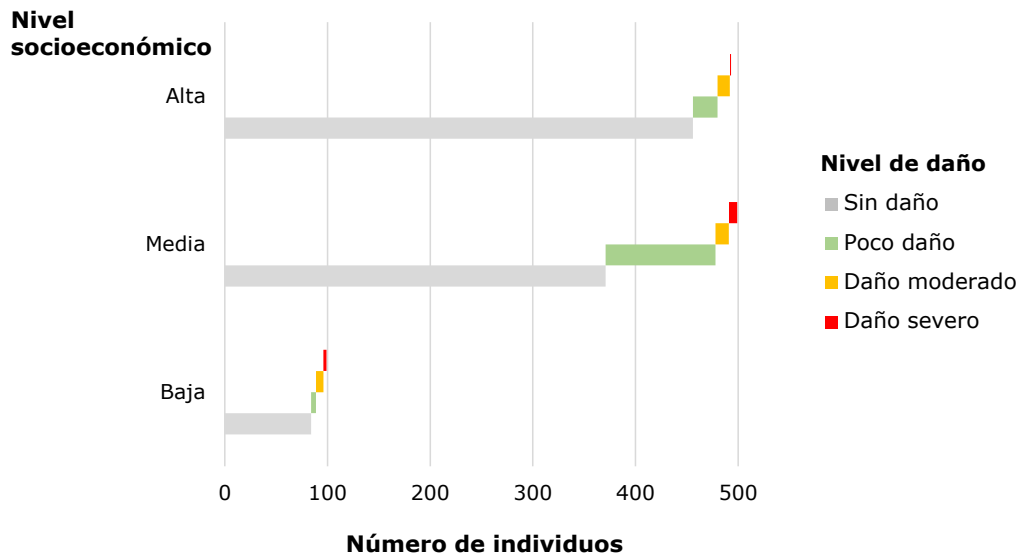
Número de individuos = Number of individuals; *Nivel de daño* = Damage level; *Sin daño* = No damage; *Poco daño* = Slight damage; *Daño moderado* = Moderate damage; *Daño severo* = Severe damage; Socioeconomic level; Alta = High; Media = Medium; Bajo = Low.

Figure 5. Relationship between damage to the infrastructure of parks and public squares and socioeconomic status.

Socioeconomic level, as a social factor, significantly explained the possibility of repairing the damage caused by woody individuals to the infrastructure (Figure 5).

Based on the total number of trees and palms by socioeconomic level, the highest percentage of individuals that caused severe damage was significantly higher in the low socioeconomic level (3 %) than in the average (1.6 %) and high levels (0.2 %; $\chi^2 = 83.1, p < 0.001$). In parks and squares located in high socioeconomic areas, there was a significantly higher number of individuals not associated with damage (92.5 %), compared to the medium (74.3 %) and low (84.9 %) socioeconomic areas. This is because the high socioeconomic areas have the possibility of repairing the damaged infrastructure, which gives an appearance of absence of damage due to the poor location of the tree species.
